OH-6A

ACCIDENT SUMMARY

PREPARED BY THE U. S. ARMY BOARD FOR AVIATION ACCIDENT RESEARCH, FORT RUCKER, ALABAMA

1 February 1965 through 30 June 1967

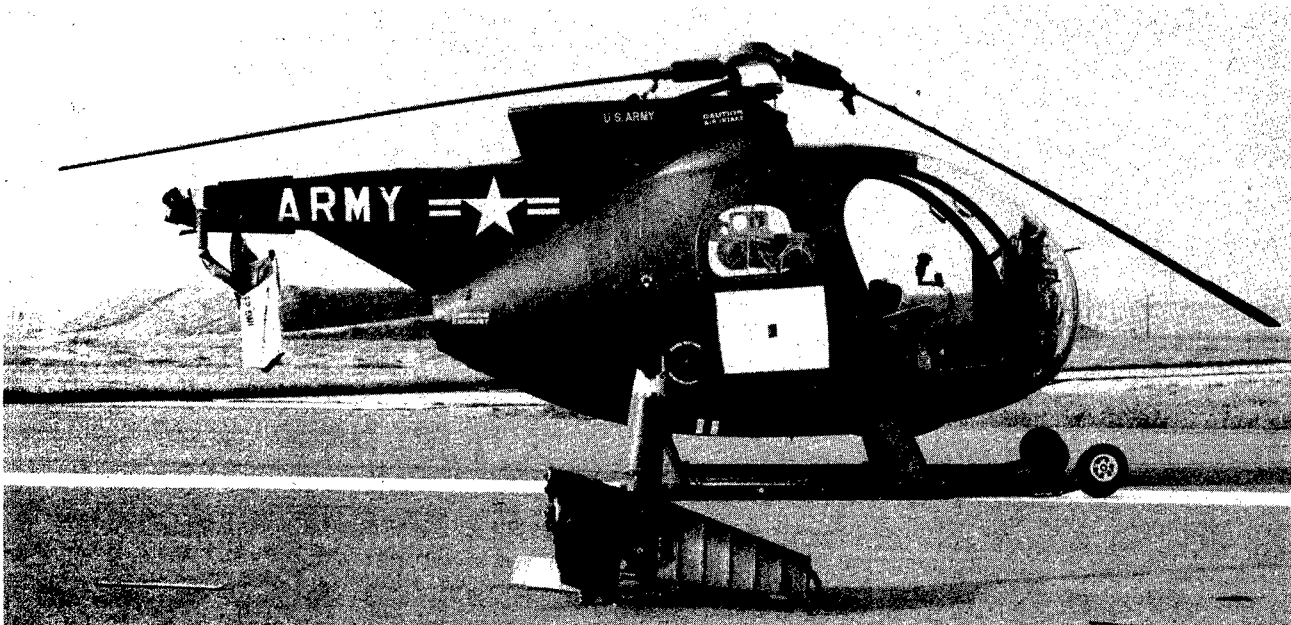
E252

E252—A test pilot, with a flight test engineer aboard, was making a practice autorotation. The maneuver appeared normal to the pilot and qualified ground observers. The helicopter touched down in a near level attitude with minimum forward speed. Immediately after touchdown, a main rotor blade struck the tail boom, severing the tail section and damaging the main rotor. The landing was made on a smooth hard surface runway. The helicopter slid approximately 14 feet from the point of touchdown and turned 20° to the left of the runway heading. The engine was

shut down and the main rotor allowed to stop before the crew got out.

CAUSE—Pilot technique of immediately lowering collective and applying aft cyclic control after touchdown, coupled with the sink rate, slight nose high attitude, and low rotor rpm, resulted in the main rotor striking the tail boom.

RECOMMENDATIONS—The board recommended: 1. A timely analysis of available data be accomplished to identify possible problem areas for future testing. 2. A means of determining clearance between the rotor blades and fuselage be employed when conducting tests of this nature. 3. A more accurate means of providing the pilot with information on absolute altitude and wind be incorporated in future testing involving critical maneuvers. 4. A warning type paragraph be included in the OH-6A Pilot's Handbook concerning the possibility of the main rotor blade striking the tail boom during autorotative maneuvers.

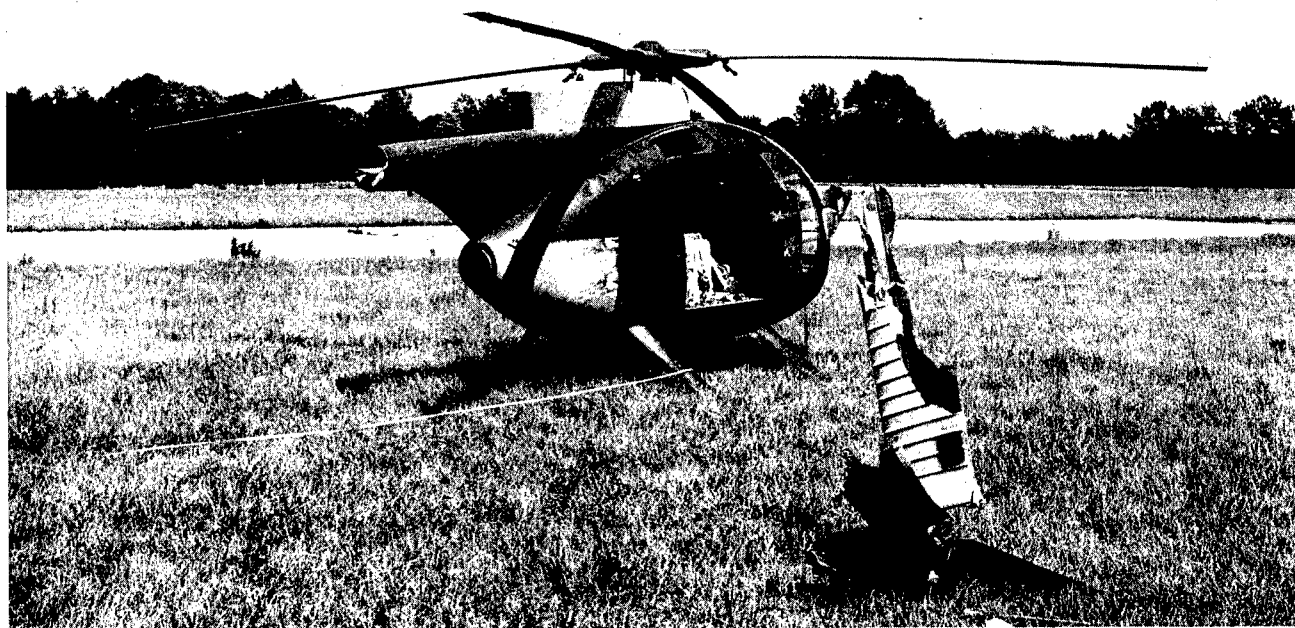
67051220

67051220—The IP and pilot took off with a gross weight of 2,340 pounds, 60 pounds under maximum gross weight. The accident occurred during a practice touchdown autorotation after 30 minutes of flight. The autorotation was made to the sod area between two runways. The aircraft landed in a tail low attitude. When it rocked forward, the main rotor blades

flexed down and severed the tail boom. The empennage arced upwards and forward into the main rotor disc. Skid marks on the ground showed the aircraft slid 55 feet after touchdown. It came to rest in an upright position on a heading of 130°, 10° left of the runway heading.

CAUSES—Instructor pilot allowed aircraft to land tail low. He did not demonstrate procedure for autorotations with loads before allowing pilot to practice autorotation with load. Probable factors were: Skid shoes used on the OH-6A create excessive drag on sod touchdowns. Main rotor blade clearance over the tail boom is less than desired.

RECOMMENDATIONS—The board recommended: 1. All instructor pilots be directed to comply with the printed syllabus of instruction. 2. The OH-6A Standardization Guide, paragraph 2, lines 3-34, and TM 55-1520-214-10, be reviewed to determine whether the operating techniques now used are satisfactory for the aircraft. 3. An improved skid shoe be designed for the OH-6A. 4. A positive safety latch be developed and installed on OH-6 engine access doors. 5. An engineering study be conducted by higher headquarters to establish a minimum safe blade clearance over the tail boom that can be measured by ground crewmen on a periodic basis.

The following actions relating to the above have been initiated: 1. All OH-6A helicopters have been equipped with smooth skids. 2. An EIR project has been established and the manufacturer is presently developing an Engineering Change Proposal (ECP) to provide improved engine compartment door hinges and positive safety latches. 3. Urgent TB 55-1520-214-20/9, 22 May 67, required an immediate inspection to determine rotor blade droop angle. If the blade droop is more than 6°, washers are installed on three bolts between spacer and striker strip, to adjust droop to range from 5° to 6°. 4. A probable or suspected cause factor that should be considered in this accident is the execution of a practice touchdown autorotation at near maximum gross weight at a high (2,550 feet) density altitude and in a crosswind. Combined, these elements reduced the margin for error.

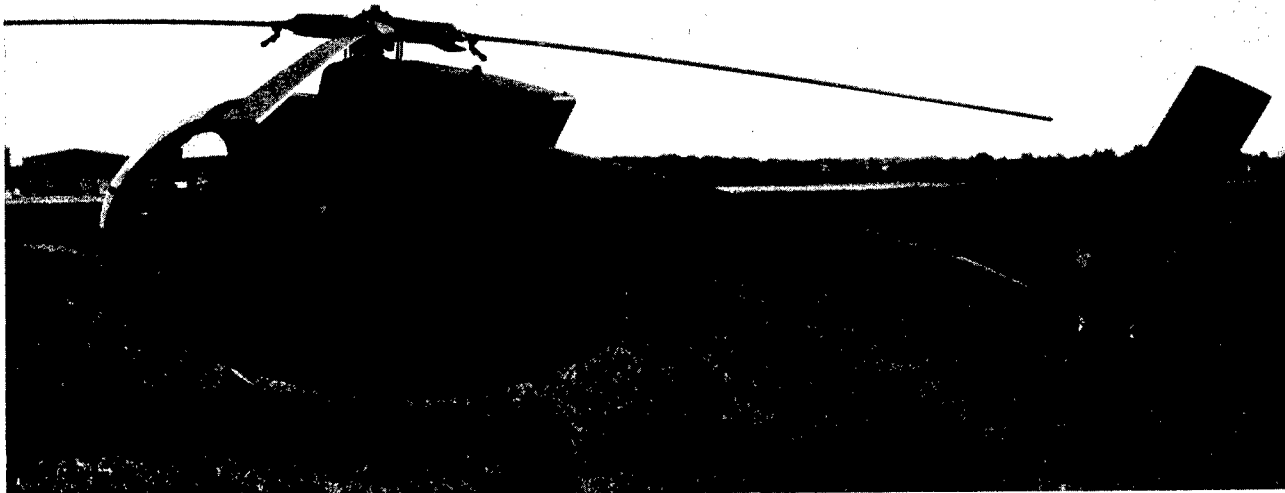
67052402

67052402—Engine instruments indicated normal on

final for practice 180° autorotation. The pilot started his flare at approximately 60 feet and made his initial pitch pull at 10-15 feet. He then cushioned his touchdown with additional pitch. It appeared smooth and normal. As the aircraft neared the end of its ground slide, the engine reportedly surged. Collective pitch was approximately two-thirds to three-quarters of the way in the up position at this point. At the same time as the reported power surge, the aircraft became airborne and began turning rapidly to the right. The IP took control and applied full left pedal, with no apparent response. The aircraft continued to spin before striking the ground on the left rear skid in a tail low attitude. The tail boom skid hit the ground, twisting the tail boom, and causing the tail rotor to strike the ground. The aircraft bounced into the air and continued to turn to the right. The throttle was checked to insure it was in the flight idle position, but the engine continued to accelerate. The IP reduced collective in an effort to land. The aircraft landed hard, skid heels first, still turning to the right and moving slightly to the rear. It came to rest upright.

CAUSE—The most probable cause of this accident was the instructor pilot or pilot inadvertently applying power during the completion of the autorotation, causing the aircraft to become airborne and uncontrolled.

RECOMMENDATIONS—The board recommended: All pilots be cautioned that it is imperative for the throttle twist grip to be held against the idle stops during pitch application for termination of autorotations and that the collective pitch must be full down prior to adding power during all ground roll operations.

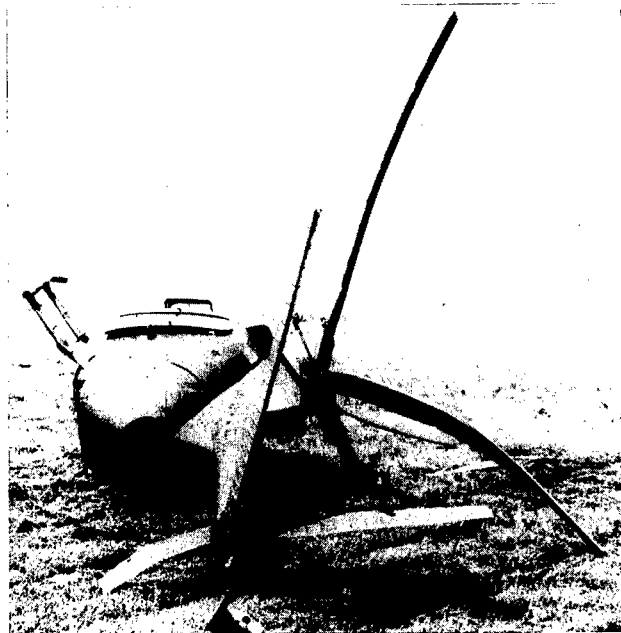
67052503

67052503—The test pilot had been flying for 3 hours, compiling data to verify the height-velocity curve at gross weights of 2,200 and 2,400 pounds. The next phase of testing was started with a change of autorotation entry, airspeed, and time delay. These changes were 30 knots airspeed with a 1-second time delay. Two autorotations, using the above criteria, were made by the copilot. He was not satisfied with the results because he felt they were marginal. The pilot did not consider the copilot's method of acceleration to the desired 50 knot flare speed as the best procedure because he felt the approach angle attitude was too steep. The pilot then entered autorotation at 200 feet agl, indicated airspeed of 30 knots, and a 1-second time delay prior to flight control

movement after chopping the throttle. A lesser dive angle was used to accelerate to the required 50-knot flare speed. This airspeed was never attained. An attempt to flare at an indicated airspeed of 47 knots was discontinued at near level attitude when it was noted that the usual buildup which accompanies the flare was not apparent. The sink rate was high and not abating, so the pilot immediately leveled the helicopter and applied partial collective pitch and full throttle. These actions slowed rate of descent slightly. The aircraft struck the ground in a level attitude with an approximate forward airspeed of 40 knots, fracturing all four landing gear struts. The left skid completely separated, causing the aircraft to pivot to the left more than 360°. It came to rest on its left side.

CAUSE—The cause was determined to be pilot

technique, while operating in the extremely hazardous area of the height-velocity curve. This technique resulted in an extremely high sink rate. The pilot then attempted an abort. However, recovery was started too late to prevent ground contact.

RECOMMENDATIONS—The board recommended: When test pilots are to determine a helicopter's height-velocity curve, extreme care should be exercised when approaching this critical curve area. Operation in the critical area of the curve should

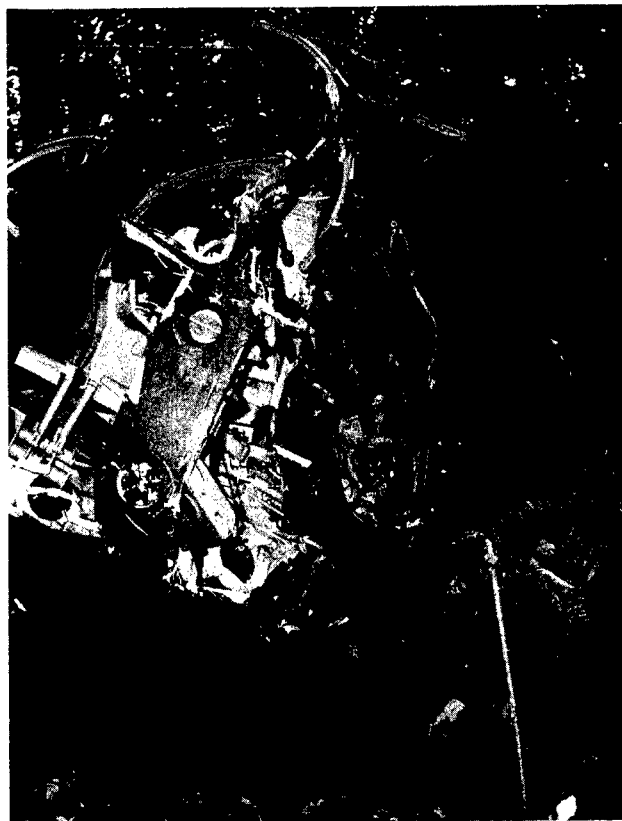
67053101

67053101—The aircraft was following a flight of four UH-1's to the home station at 500 feet when the tailpipe outlet temperature (TOT) rose. The pilot reduced airspeed and power, descended, and continued over heavily wooded terrain. The estimated altitude at the time of engine failure was approximately 200 feet. After the engine quit, the pilot

CAUSES—Engine failure was attributed to a manufacturing defect—fatigue failure of fourth stage compressor blades from oxidation caused by inadequate removal of heat treat scale during production. Failure of these blades resulted in failure of the fourth, fifth, and sixth stages of the compressor. This caused a reduction in airflow, high turbine temperatures, loss of power, then complete engine failure. The pilot elected to continue flying with a high TOT before the engine failed, rather than execute a precautionary landing in the nearest suitable landing area. His decision was based on procedures outlined in TM 55-1520-214-10. He did not maintain altitude or select a flight path to provide access to a suitable forced landing area during an apparent emergency.

RECOMMENDATIONS—The board recommended:

1. Better quality control measures to prevent faulty parts from being installed in engines during manufacture.
2. Emergency procedures in TM 55-1520-214-10 be reviewed to insure precautionary landings are made in the nearest suitable areas when sudden increases of TOT exceed 749° C and load reduction

does not correct the condition. 3. More emphasis on pilot training in selection of emergency landing areas, and in maintaining altitudes that will permit safe emergency landings.

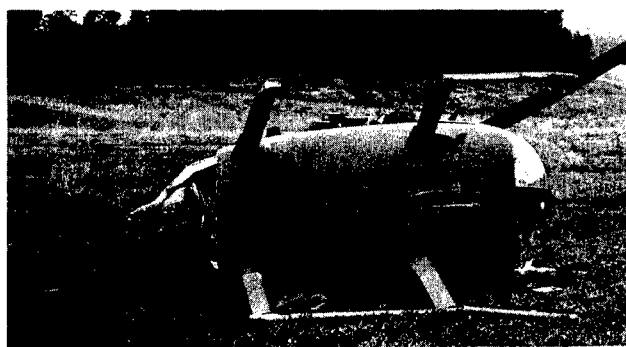
67061507

67061507—The aircraft was returning from a training flight for refueling. Nearing the airfield, the pilot started a descent. As he did, the rotor and engine rpm increased toward the red lines. The pilot increased collective, called his wingman, and informed him of the difficulty. As he lowered collective to start the approach, the engine and rotor rpm began to increase again. The pilot continued to lower collective to approximately 23 pounds of torque. The aircraft leveled off at 20-30 feet and would not descend. A go-around was made. On the second ap-

proach, the pilot used the governor control beep switch and beeped the engine to low range for 10 seconds. He then began the approach by lowering collective. The engine and rotor again went to 110% and 514 rpm and the aircraft would not descend. On the third approach, the pilot used the same technique of keeping the engine down to low range and also closed the throttle to the ground idle position. Again, the aircraft would not descend. On the fourth approach, the pilot attempted to get as low as possible before reaching the field. As he started the approach with the engine beep at low range and throttle closed to ground idle position, the engine and rotor rpm started increasing and the aircraft began a slow climb. The pilot lined the aircraft up with the runway, completely closed the throttle, and entered autorotation. Rotor rpm on entry was 520, altitude was 20-30 feet, and airspeed approximately 40 knots. The pilot began a slight flare at approximately 12 feet and pulled pitch at approximately 6 feet. The aircraft touched down heels low and slid 32 feet before becoming airborne again. During the ground slide, the yellow main rotor blade struck the top of the tail boom, causing it to snap violently. This snap caused the coupling between the tail rotor drive shaft and tail rotor gearbox to separate, resulting in loss of antitorque control. At this point, the aircraft became airborne, possibly from application of aft cyclic. It yawed to the right with the heel of the right skid striking the ground. The red and black blades struck the tail boom and ground, causing the aircraft to spin to the left. It came to rest on its left side.

CAUSES—Engine and rotor overspeed due to failure of the fuel control governor. This failure was caused by a small piece of nylon (used as a thread locking device) lodged in the Py bleed orifice. The pilot used poor judgment and technique in starting an autorotation at low altitude and airspeed in the caution area illustrated by the Flight Envelope Curve Chart in TM 55-1520-214-10. Supervisory error was evident on the part of the IP at ground control for advising the low shallow approach.

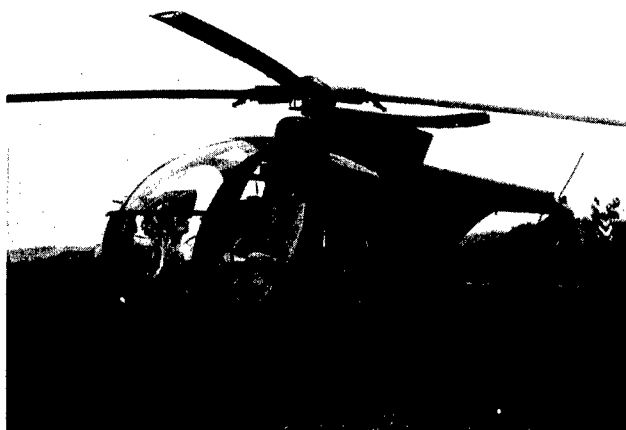
67062708

CAUSES—IP allowed the pilot to hold centered or slightly aft cyclic during initial touchdown, with possible further aft cyclic movement after touchdown. This, combined with full collective travel prior to touchdown, caused a harder than normal touchdown. Low rotor rpm resulted in the main rotor striking the doghouse and tail boom.

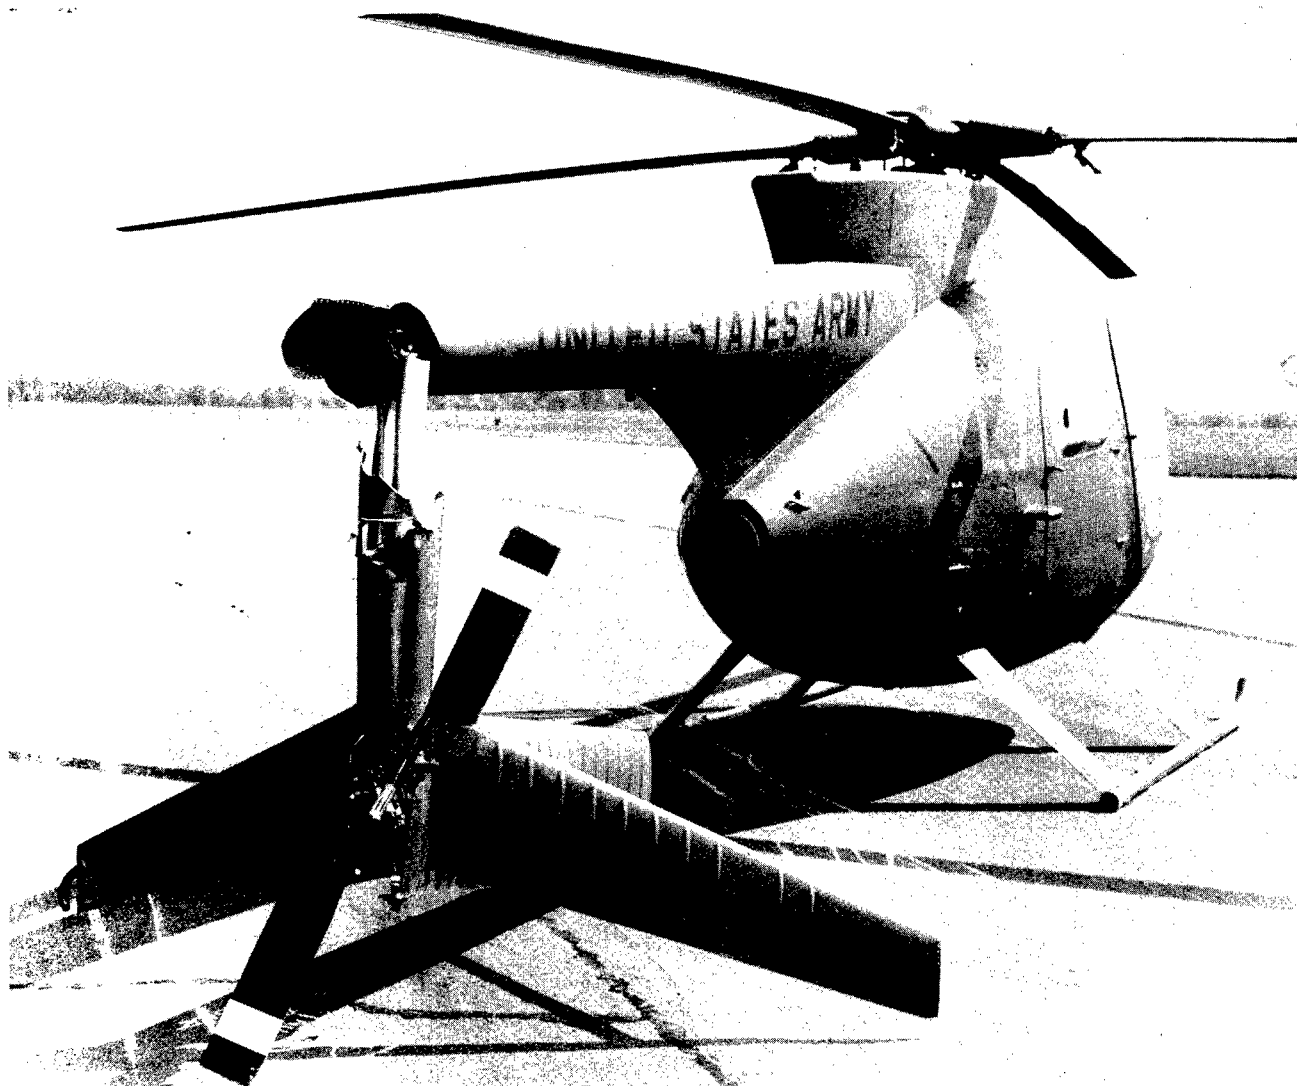
67063003

67063003—After flying 1 hour with one pilot, the IP landed and picked up another pilot without shutting down the helicopter. Six hovering autorotations were made. IP requested and received permission to use the active runway for autorotations because the sod area was too wet. He then let the pilot attempt a straight-in autorotation, entering at 500 feet. Normal deceleration was made to approximately 60 knots, rotor rpm was stabilized in the green, and a decel-

erative flare was started at 50-75 feet. Initial pitch was applied at approximately 10 feet. The right skid struck the ground at approximately 5 knots forward speed. The helicopter skipped off the ground and left cyclic was applied. Shortly after initial ground contact, the red main rotor blade struck the tail boom, partially severing it. Directional control was lost and the helicopter slid 27 feet from point of initial contact, turning approximately 43° to the right. The engine continued to run and was shut down by the crew.

CAUSES—The static main rotor blade droop angle was 1° out of tolerance due to inadequate inspection. It was suspected that the pilot landed slightly tail low with low rotor rpm, allowing the main rotor blade to flex down and strike the tail boom.

RECOMMENDATIONS—The board recommended: 1. Rigid inspection requirements of the OH-6A static droop angle to prevent recurrence. 2. Acceptance facilities establish procedures to insure the static droop angle is correct before aircraft are accepted and assigned to units. 3. Paragraph 3-34, TM 55-1520-214-10, be changed to include a warning about
